Holly Hill Log Barn

Preservation Project

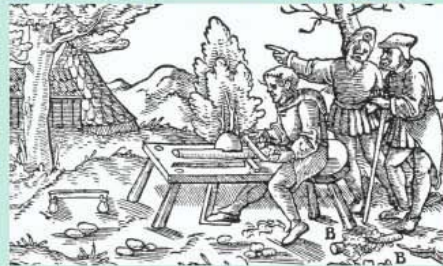
What's hand-riven siding? Strips of wood were riven by a person sitting on a shaving horse and using a draw knife. The practice is of long standing; the illustration at right is a detail from Georgius Agricola's 1556 book *De re Metallica*, based on the author's study of mining in then-Bohemia, now the Czech Republic.

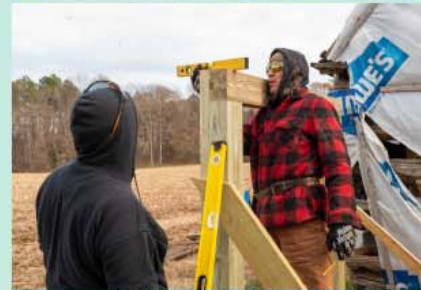
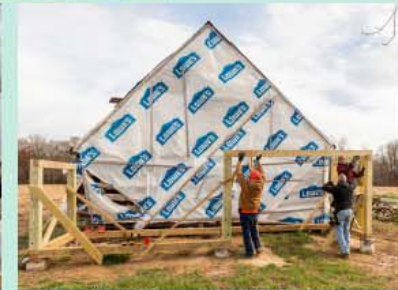
Left and center: west gable extension, December 2020; Doug Kesselring, Jeff Thompson, and Patrick Doering. Right: filling in for missing logs, January 2021; Jeff Thompson and Alan Brand.

Custom fitting came into play in the construction of the gable-end extensions and to fill a gap where deteriorated logs could not be retained.

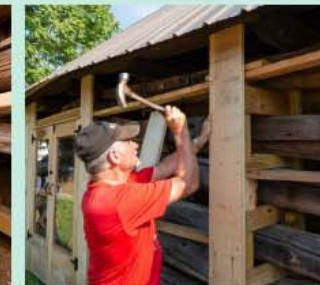
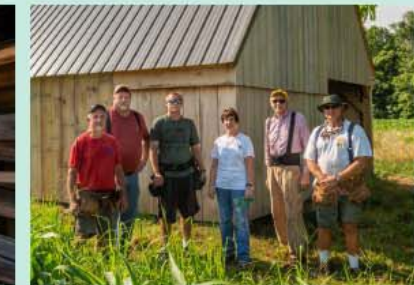
Volunteers Scott Hite, Mark Lee, Garrett Lee, Penny Moran, Carl Fleischhauer, and Steve Cloak, July 2021.

Phase 3: To wrap up the project, logs were protected by siding, a fresh version of the vertical siding removed at project start. In this case, however, Thompson prepared added wall framing so the new siding would stand off from the logs to minimize moisture damage. This framing also linked to the interior structure, thereby adding support to the logs. In July 2021, volunteers nailed up new siding.
